MB GPW G503 WWII Jeep Replace Crankshaft Seal on Timing Chain cover and Crankshaft Pulley

This article shows has multiple purposes, if you need to replace your crank shaft pulley, or the crankshaft pulley seal on the timing chain cover.

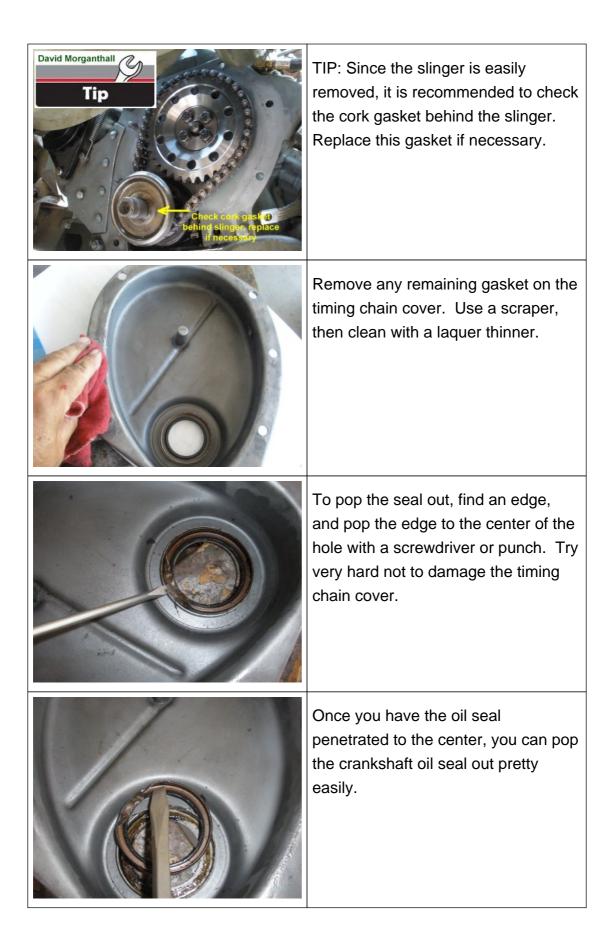
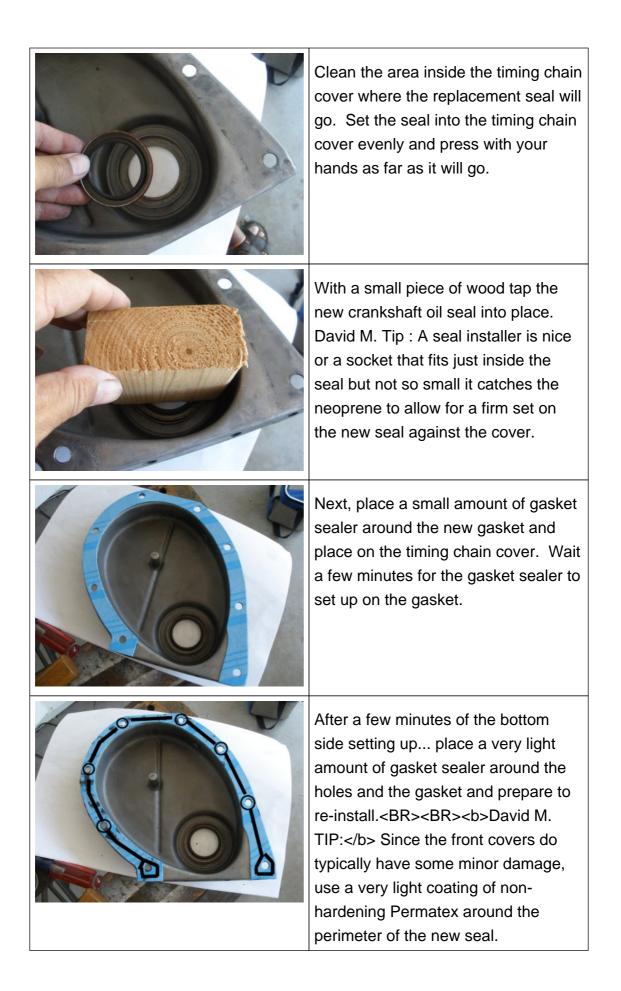
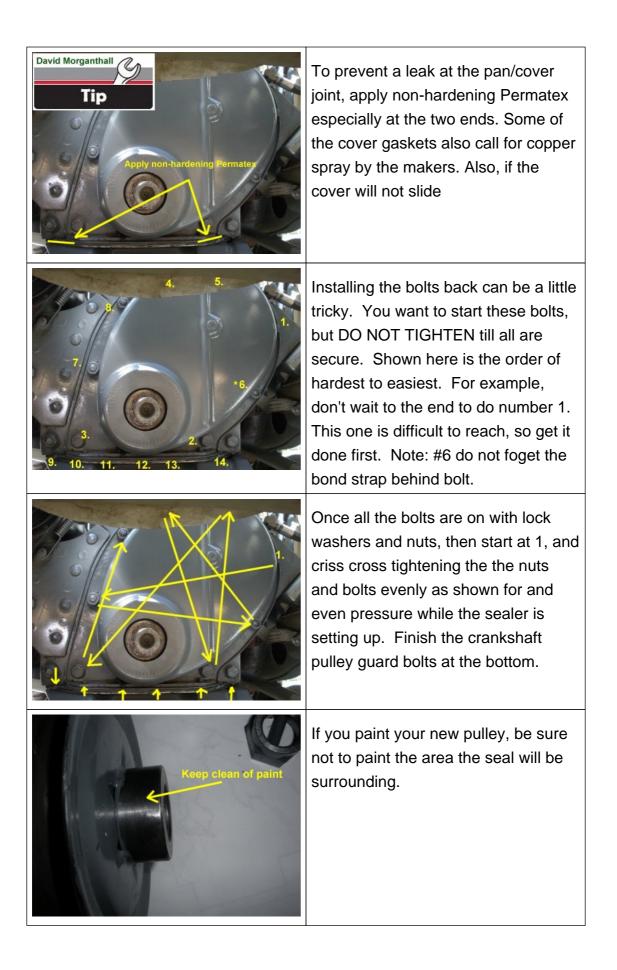
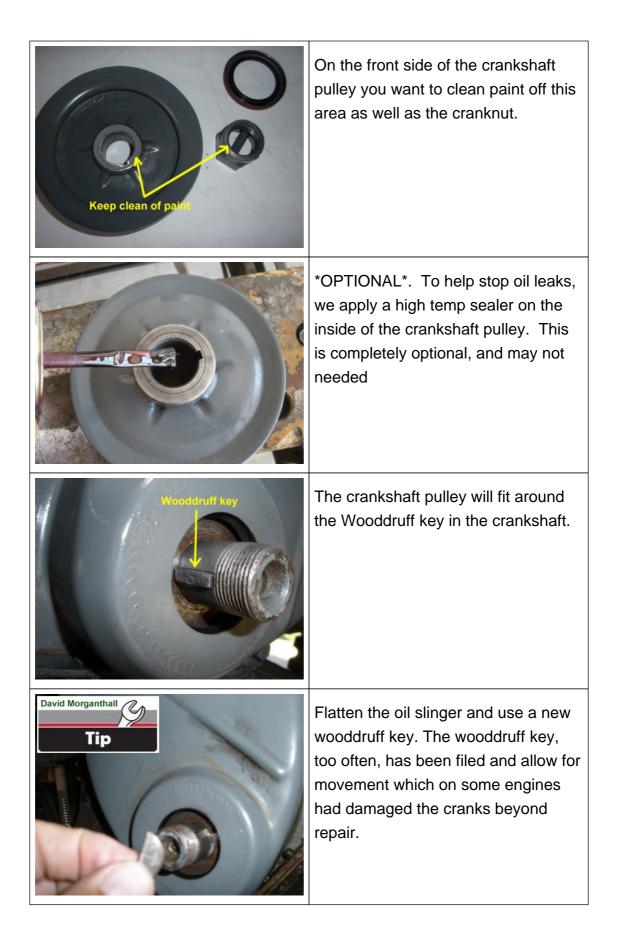
Next, remove all the bolts from the bottom pulley guard, and the timing chain cover.
Remove left over Gasket	Use a scraper to fit between the gasket and timing chain cover and start to pry off. When the cover comes off there will be partial gasket remains on the block. This needs to be removed. Continue to scrap off the remainder of the gasket.
	Here a rag is wet with laquer thinner and wipped the area where the gasket will be replaced.
	Here you see the area is cleaned off and ready for replacement. In this case the dark areas are not remaing gasket pieces, these were small pitted areas.

Wooddruff key	Now fit the crankshaft pulley over the woodruff key and press back as far as it will go.
	Add the crankshaft nut, and tighten down. Now let the sealers dry overnight, or even a couple days.
David Morganthall	The crank threads are in many cases damaged and THE REPRO NUTS ARE THE WRONG SIZE. To avoid not getting the pulley pulled in to prevent end play issues, take a flat washer and use it to guarantee the parts and all draw together. Then remove the nut & washer and reinstall the nut, then check end play. Once the pulley is in place any thread issues seem to take a back seat and allow the nut to seat correctly.
