G503 WWII Jeep Replacing Brake Light Switch

A common problem when your G503 WWII Jeep Brake Light no longer works is that the switch on the Master Cylinder has gone bad. It is not expensive or difficult to replace, here are the steps

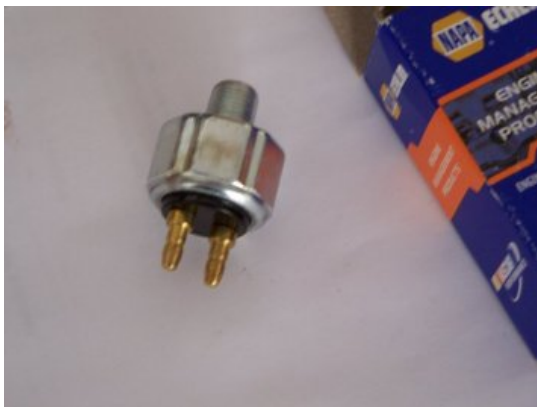
The brake light switch is about \$7 bucks from Napa or from Ron Fitzpatrick G503. I will get them from Ron, unless I am pressed for time.
