## G503 WWII Jeep Hull Streamline Bakelite Compass Restore

One great tool that is enjoyed on the WWII Jeep is the Hull Streamline auto compass. It adds history and elegance to your historical offroad vehicle. Here are some details on how to restore this cool compass

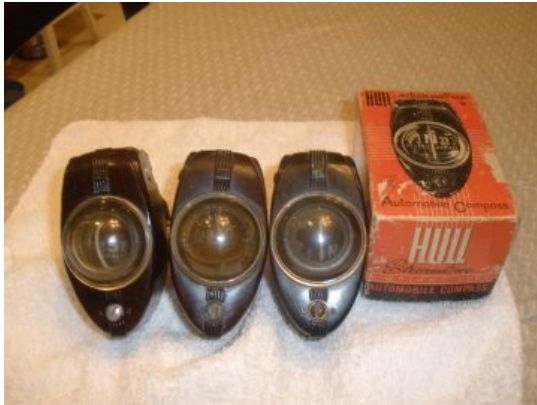
There are a couple different type of WWII Hull Streamline compass that are the correct for the WWII time period. Here you see three brown or black bakelite face plates that are the same

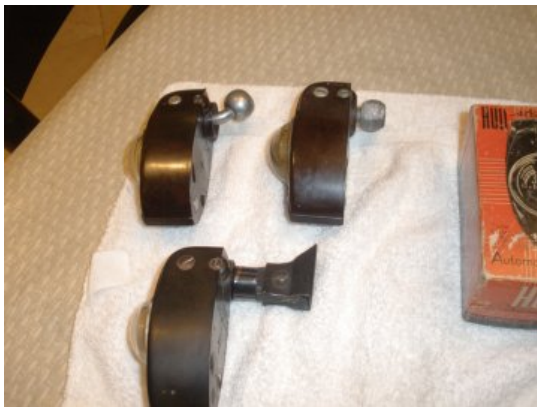
Turning these on their sides you can see a few differences. The arms that hold the compass to a Windshield or Dash, and two the screws to dismantle the magnets for the N-S and E-W screws

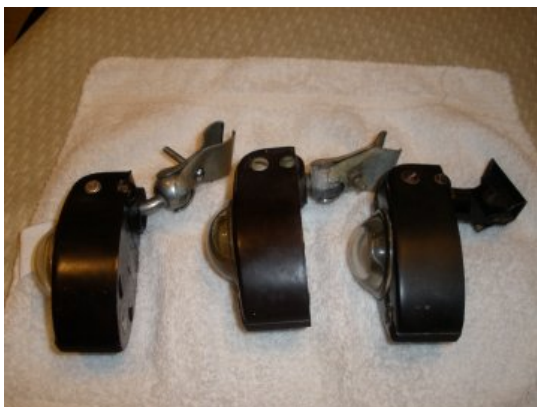
There are two different types of hinges as shown. Two which have different arms and have a clamp style and the third is mounted to a surface via screws.

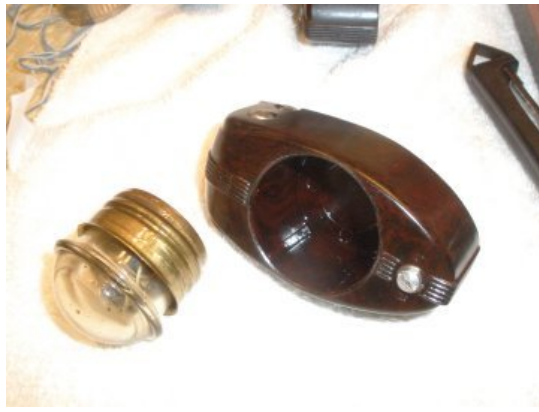
When the glass bulb pops out, you most likely will have some of the fluid all over the device from leakage. Most leak, or are short of fluid.

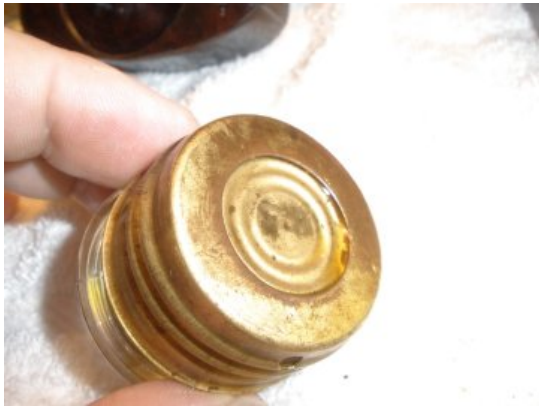
Here is a close up of what you are trying to resolve. There is a brass back plate that is usually frozen to the brass retainer.

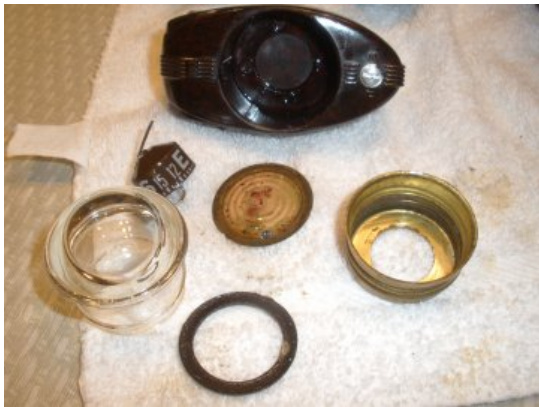
After a little time soaking in the penetrating oil, you will find that the two brass fittings will break free and you can see all of your pieces. Dump out the fluid and clean the glass.

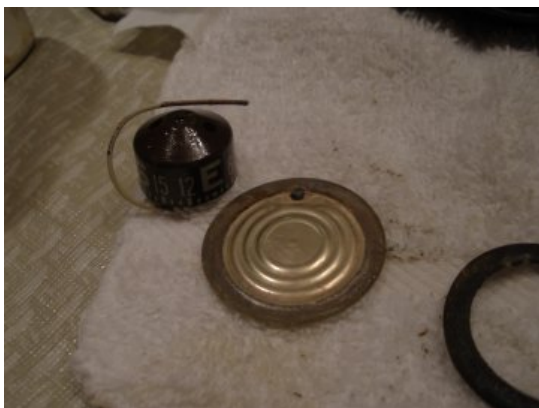
In this case you will see that the small brass "C" shaped wire broke from the back brass plate.

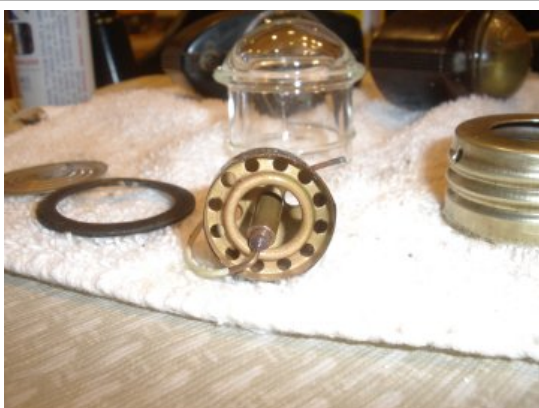
Here is a look at the bottom side of the compass spool for reference
