G503 WWII Military Jeep Radiator Rebuild Restore WW2 Restoration

This article shows a step by step process of restoring your G503 WWII Jeep Radiator - By Lew Ladwig

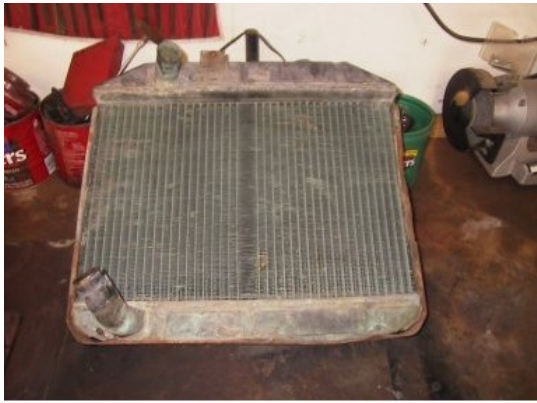
I found a good GPW radiator. Most of the thin fins are bent over but the tubes look to be OK. It has the correct 45 cut on the sides and the center missing tube. The tanks have several dents and the bottom tank is bulged out. This is probably due to freezing. My plan is: 1) Measure frame 2) remove frame 3) remove tanks 4) clean and rod 5) pound out tank dents etc. 6) straighten fins - remove tarnish 7) resolder 8) add shroud 9) add over flow tube 10) paint 11) zinc plate carriage bolts

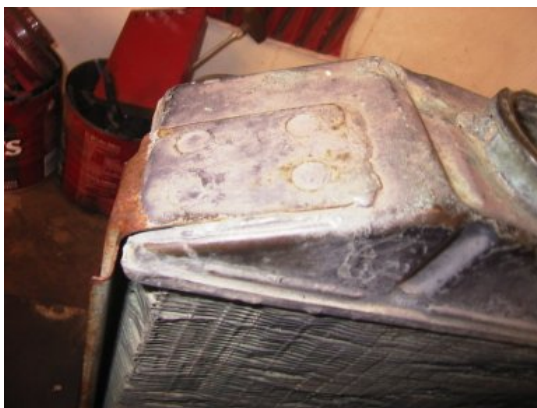
You can see where the frame is soldered to the top tank, there is also solder along the bottom and the lower corner tabs. Mine had broken the solder joint at the corners and most of the bottom.

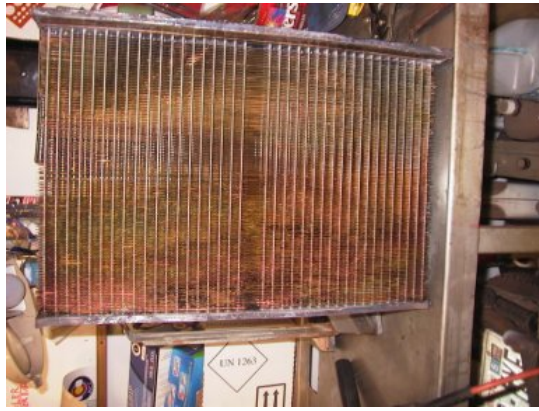
I was able to set up an acid bath. I used muratic acid from Lowes. Since things were warmer it was very effective. I flushed the core several times, gave it a water rinse, and a flush with my lye mix. Lots of dirt, paint, and copper oxides came off. Much of it was now bright copper. I continued to flush and clean inside and out. I used some triox to make sure all was clean: It was nice to see daylight between the fins and thru the tubes! It really cleaned up

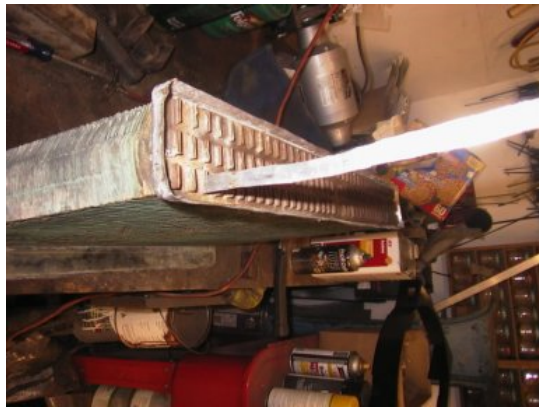
I rodded it out using a thin strip of aluminum. This works great. There is a slight crimp on the top of each tube in the center of the flat side. A couple of these needed to be opened to get my rod in there. After this I rinsed and shot each tube with a blast of air. They are good and clean. I inspected each tube with a light to be sure they were open and clean.

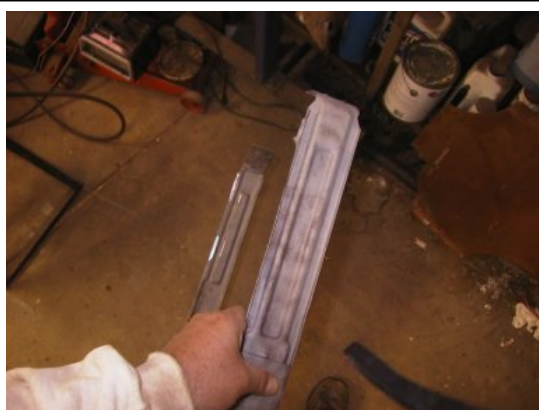
Here you see the frame is blasted

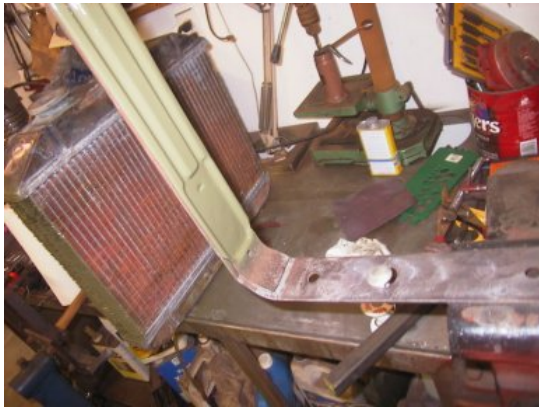
Don't forget the mounting bolts! Mine are a tight fit in the half moon so I put them in ahead of time.

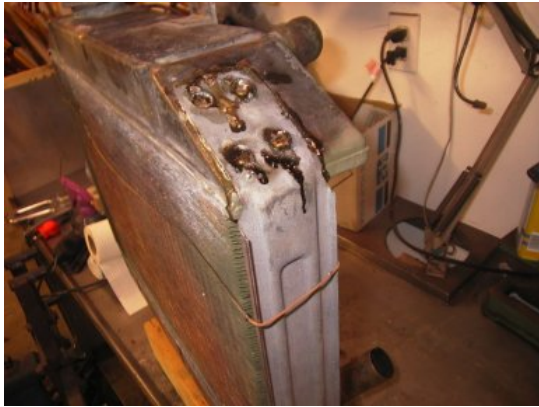
Start at one end and work around. Edge is 1/4" in from the front.

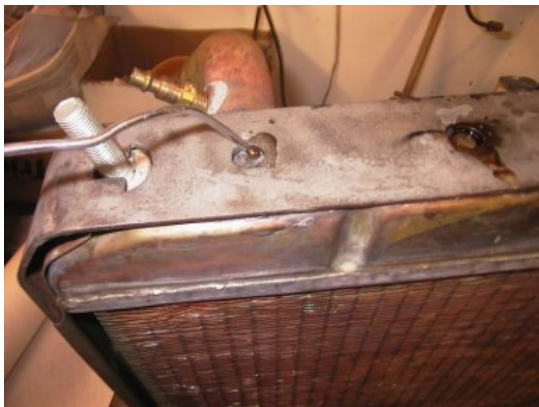
Use the access holes on the bottom to get good bonding.

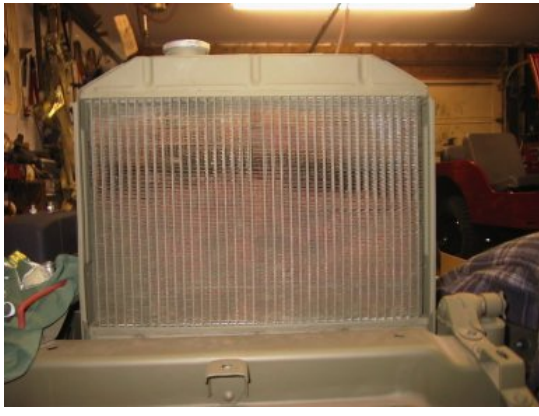
I think it came out well. I gave the whole unit a coat of OD after wiping it all down with acetone to get flux off.
